United States  
Circuit Court of Appeals  
For the Ninth Circuit.

UNITED STATES OF AMERICA,  
Appellant,

J. LESLIE MORRIS COMPANY, INC., a cor-  
poration,  
Appellee.

Transcript of Record  
(Plaintiff's Exhibits 1 to 32)

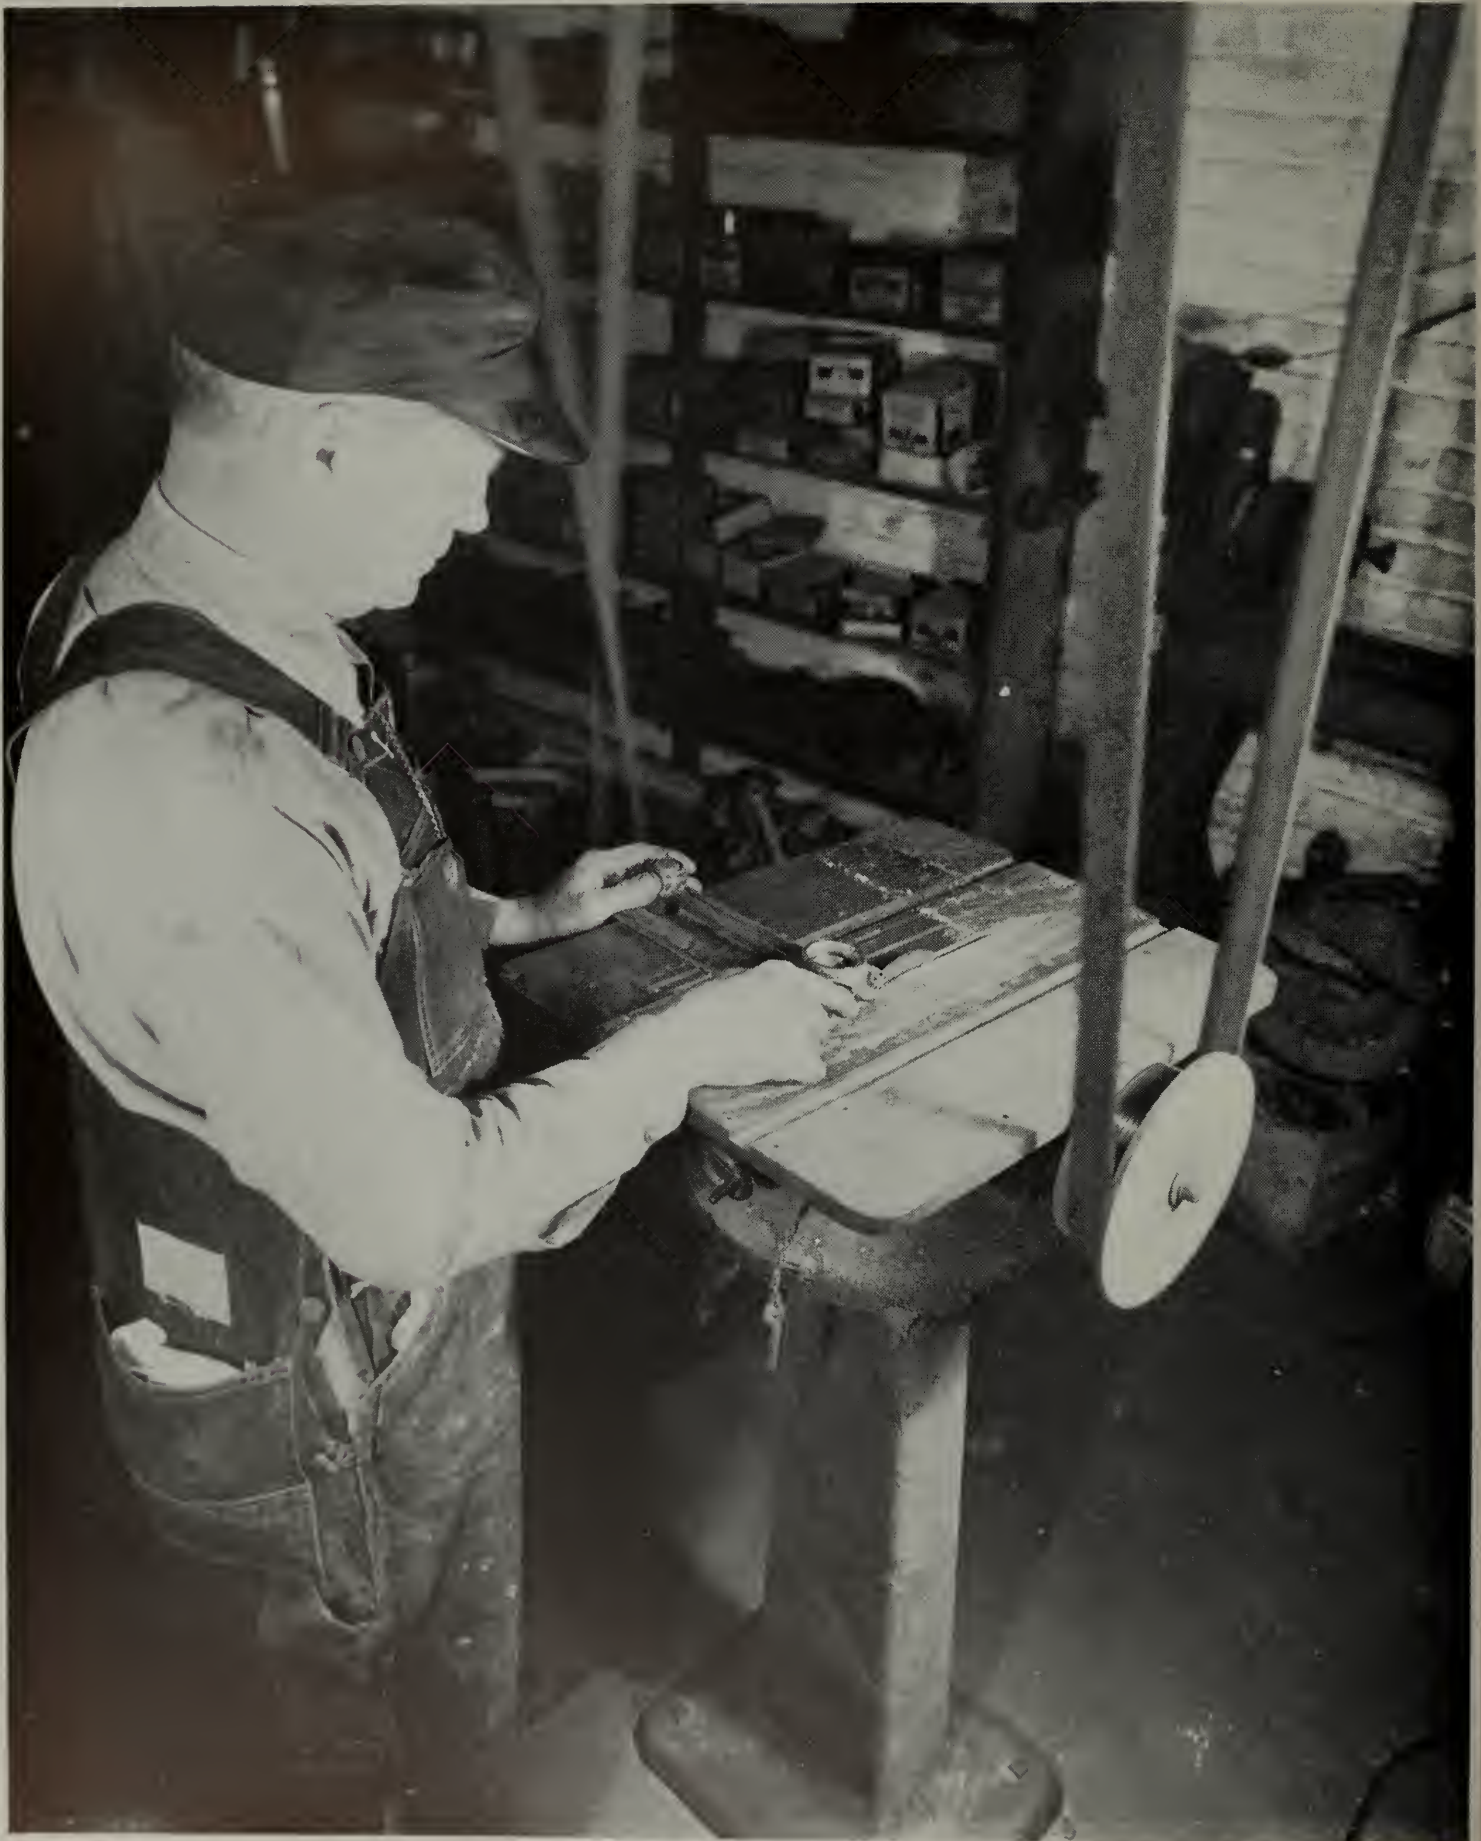
PLAINTIFF'S EXHIBIT No. 24

On Model A Ford connecting rods in which the babbitt was cast without the use of separator shims, it is necessary to cut the babbitt through the center of the bearing in order to free the cap from the shank. This operation also leaves an oil groove or relief which facilitates lubrication. This operation is performed by a slotting tool as shown in the above picture.

The Model A connecting rods are now on a saw table in which a rotating saw blade cuts the babbitt flange to complete the separating operation as shown in Picture 24. This also cuts the necessary oil relief groove through the flange.

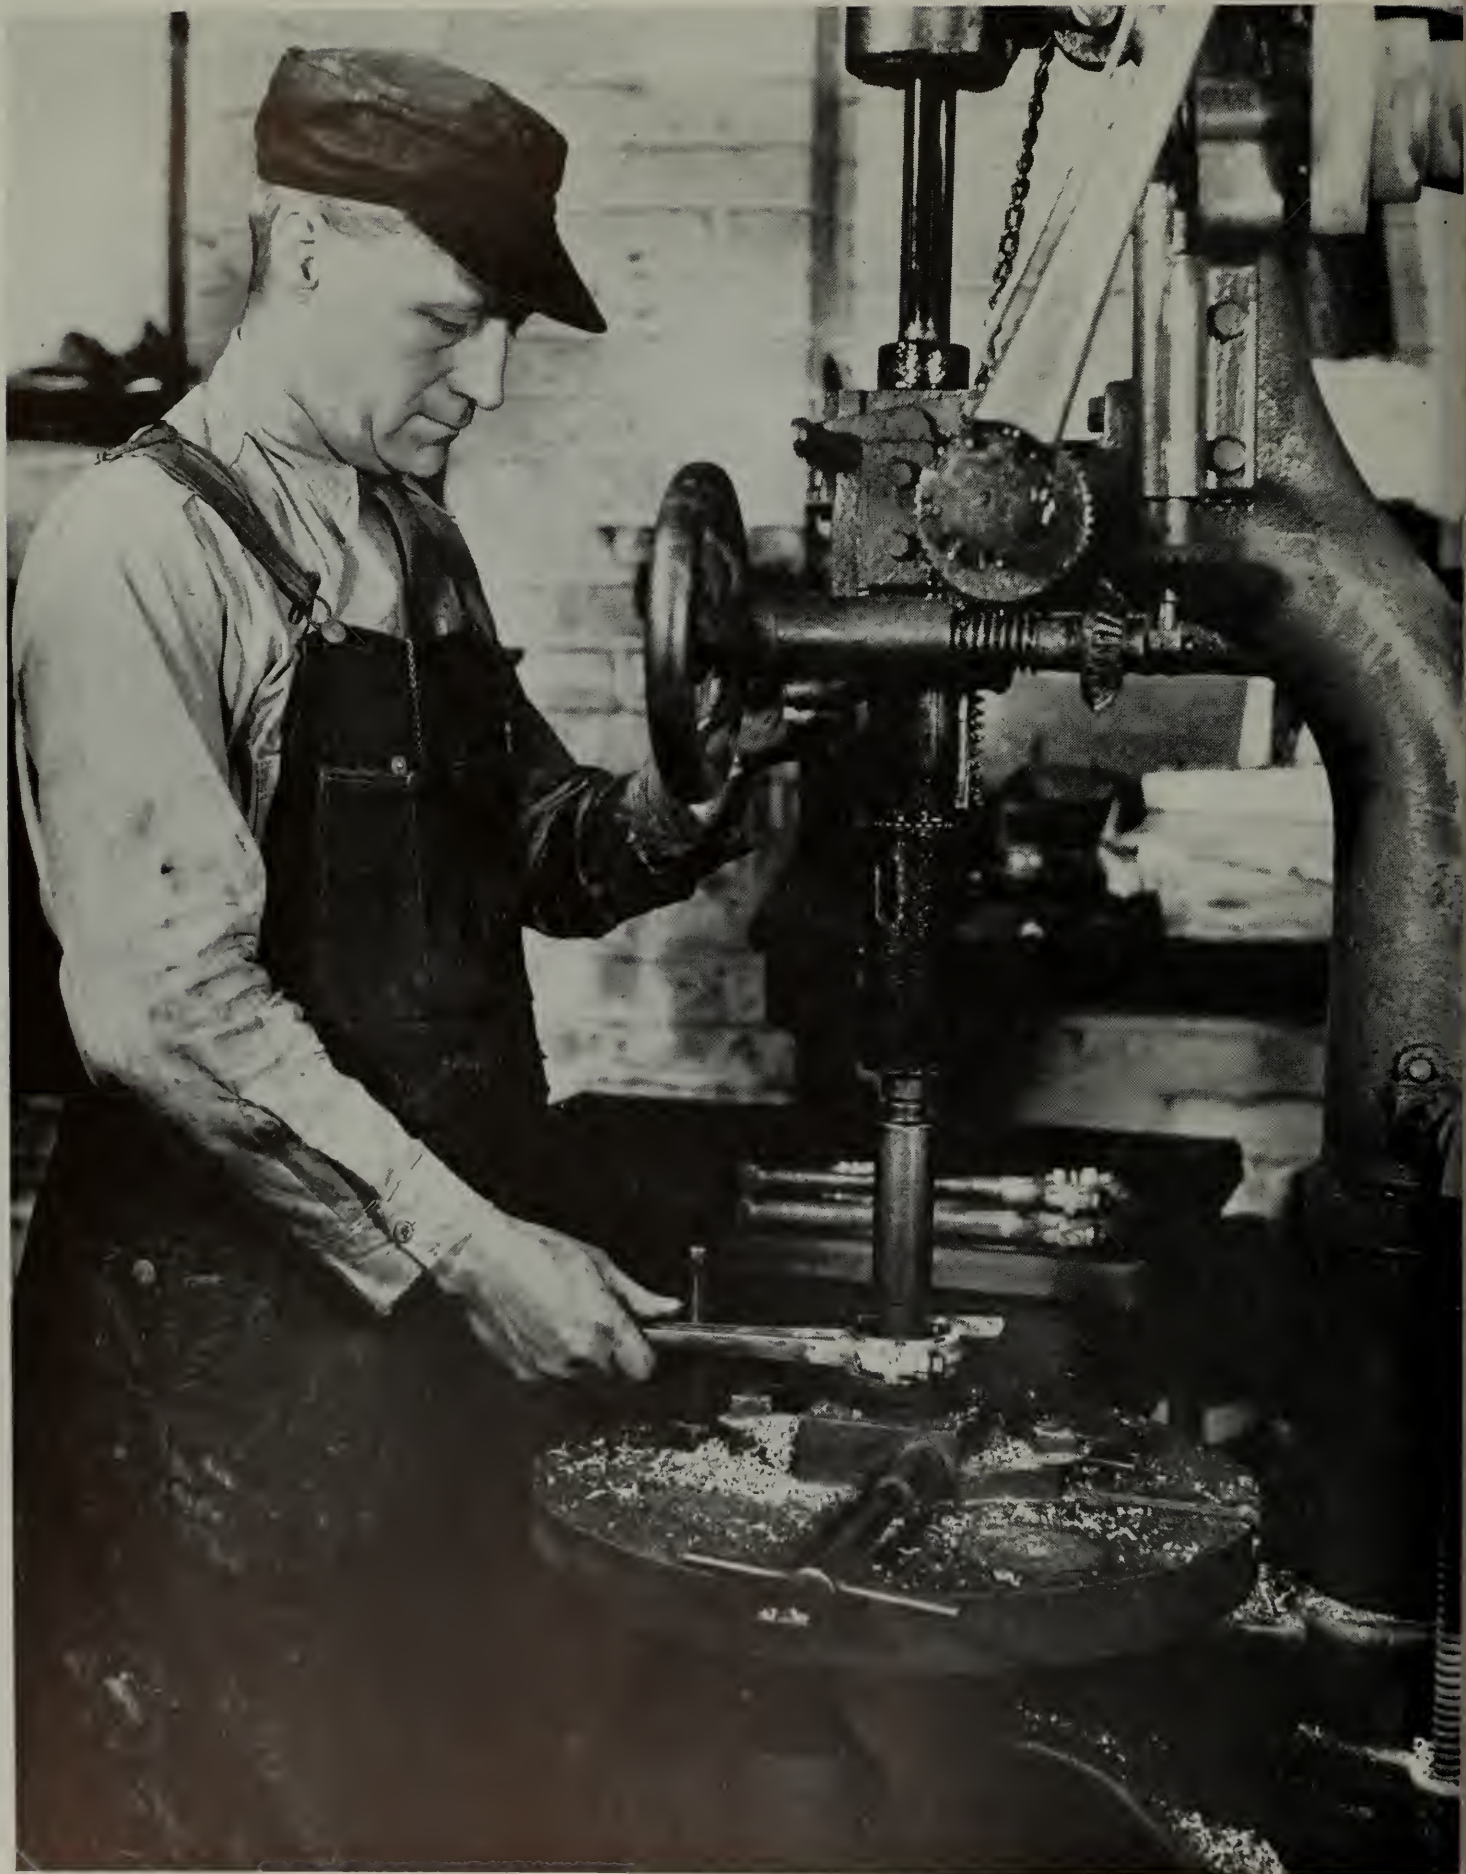
PLAINTIFF'S EXHIBIT No. 26

About one half of the connecting rods rebabbitted require new bushings in small end of the shank. These are installed by a hand operated arbor press, as shown above.

Model A Ford connecting rods are fitted with a very thin bushing which becomes somewhat damaged and burred when being pressed in by the arbor press shown in Picture 26. This is corrected by placing the connecting rods in a bench drill press in which a chamfering tool is used as shown in the above picture.

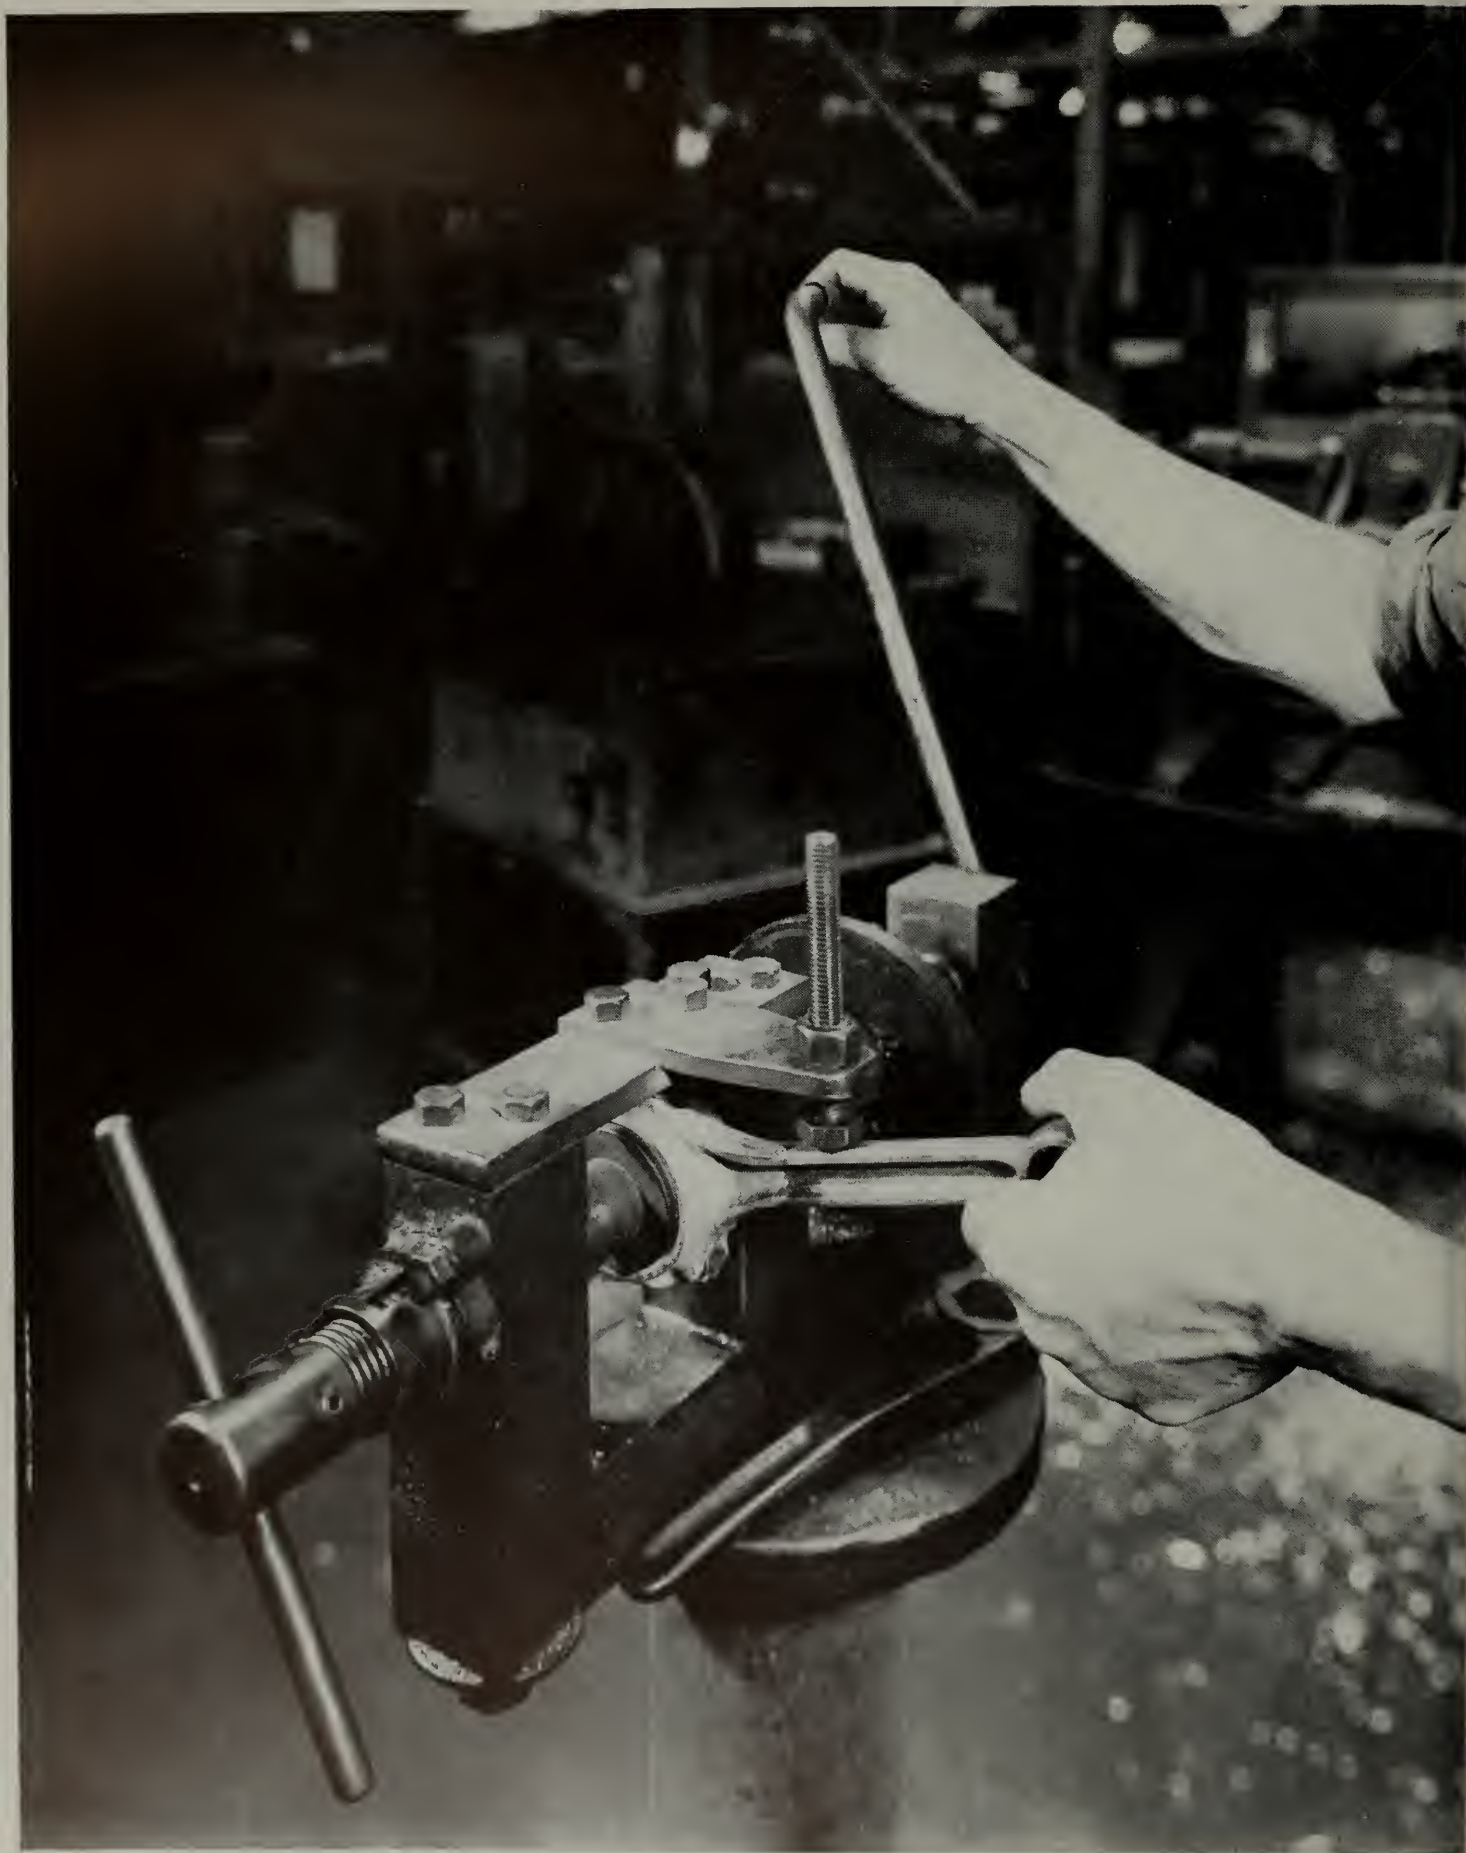
PLAINTIFF'S EXHIBIT No. 27

The outer edge of the babbitt flange is now faced by a special tool placed in a drill press. Approximately 50% of the rods re-babbitted were of a type that required this operation, which is shown in the above picture.

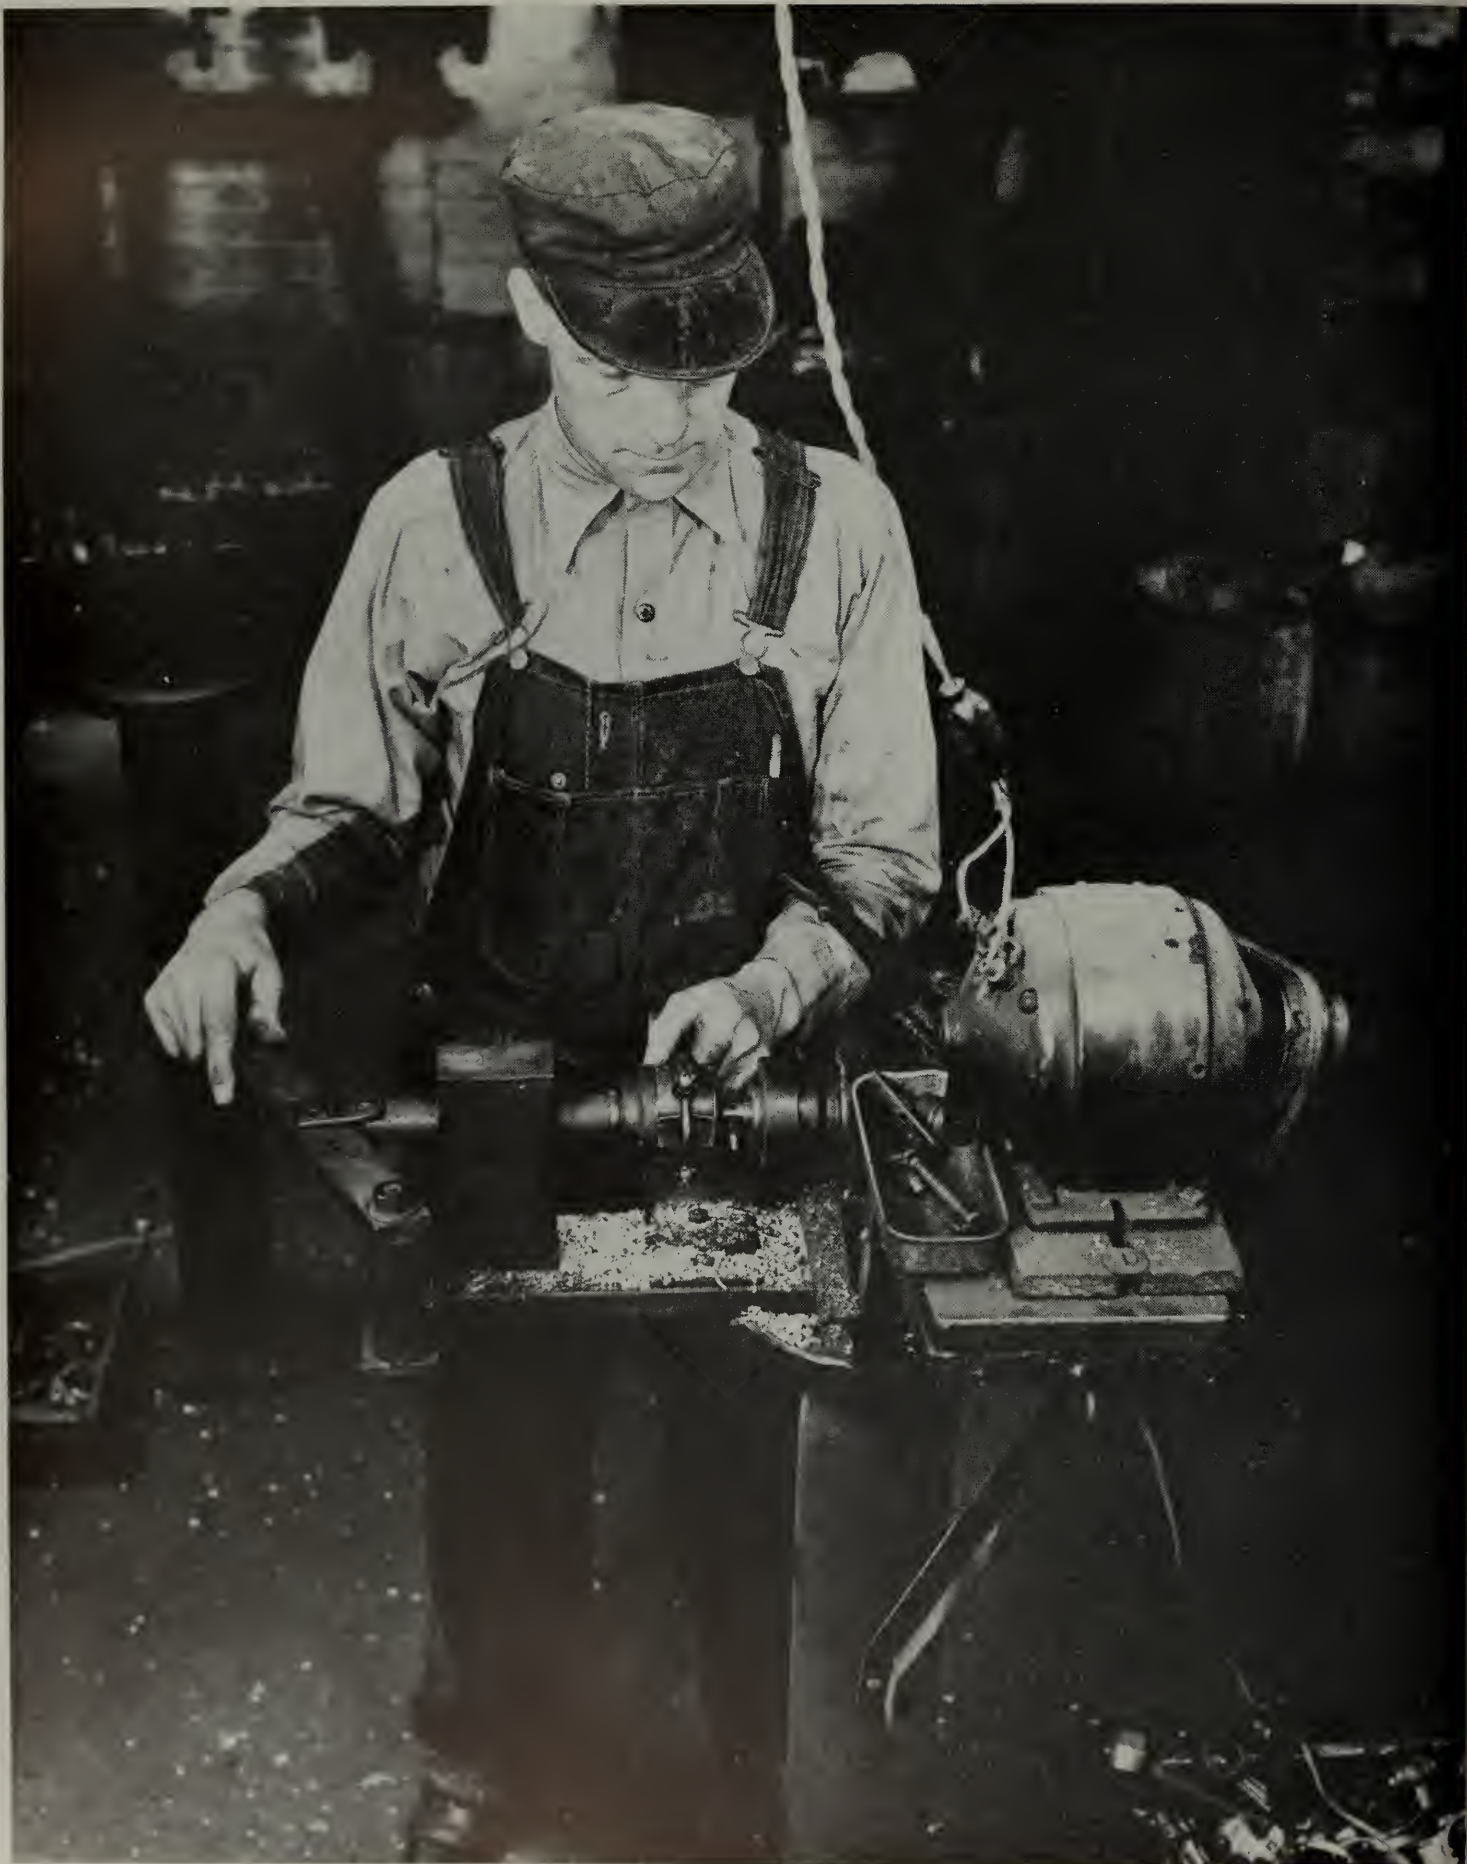
PLAINTIFF'S EXHIBIT No. 28

All Model A Ford and six-cylinder Chevrolet rebabbitted connecting rods require an oil groove on the face of the bearing which is cut in the shape of a figure 8 by hand operated oil groover as shown in the above picture.

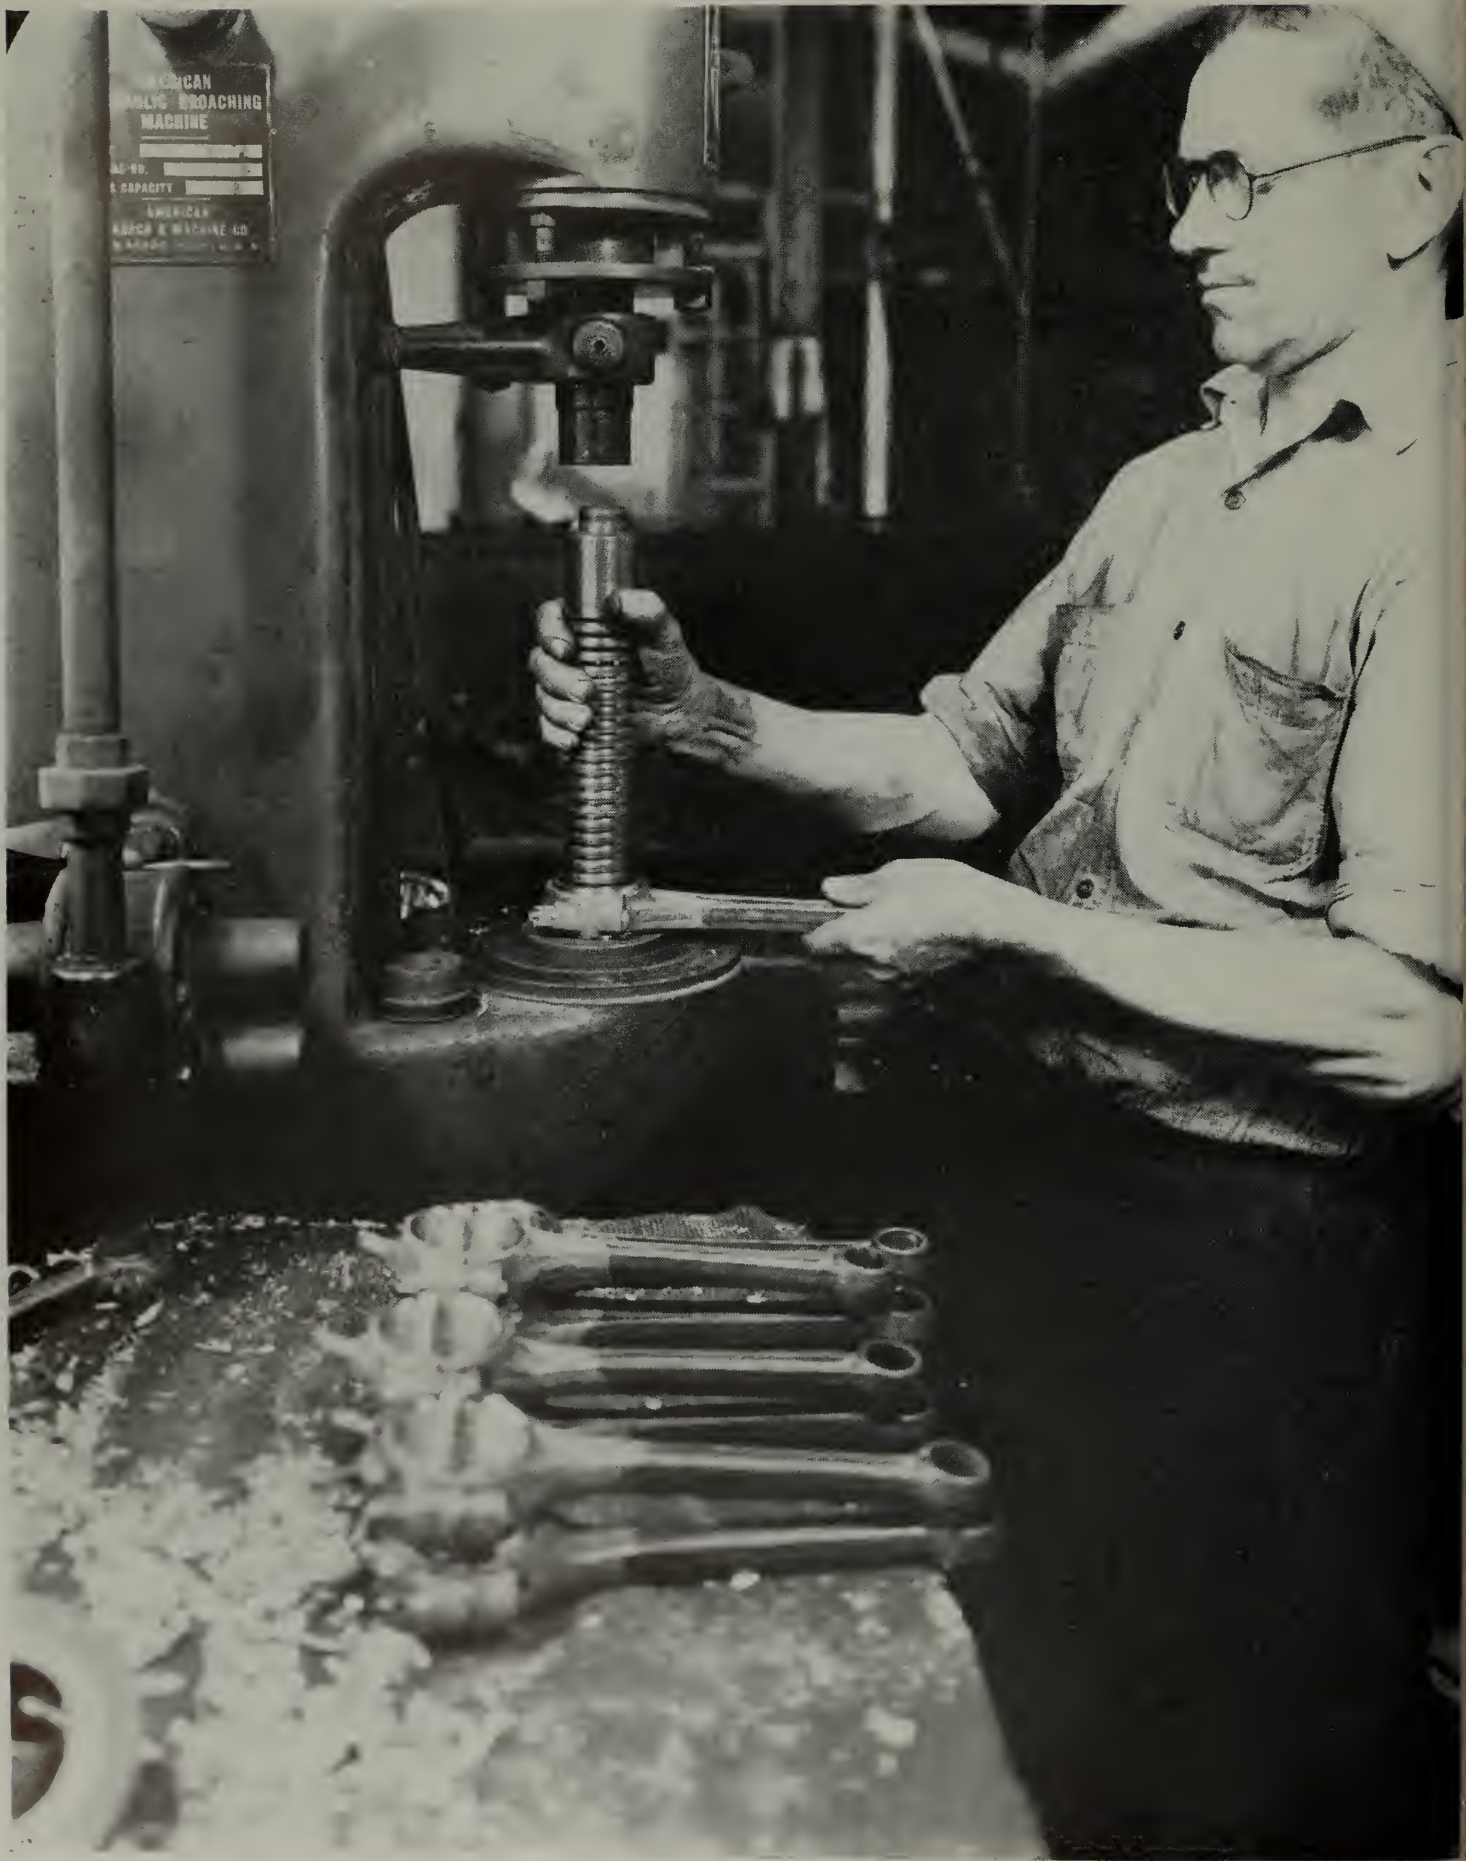
PLAINTIFF'S EXHIBIT No. 29

Certain Pontiac bearings require a continuous oil groove around the center, which is cut by the center oil groover shown in the above picture.

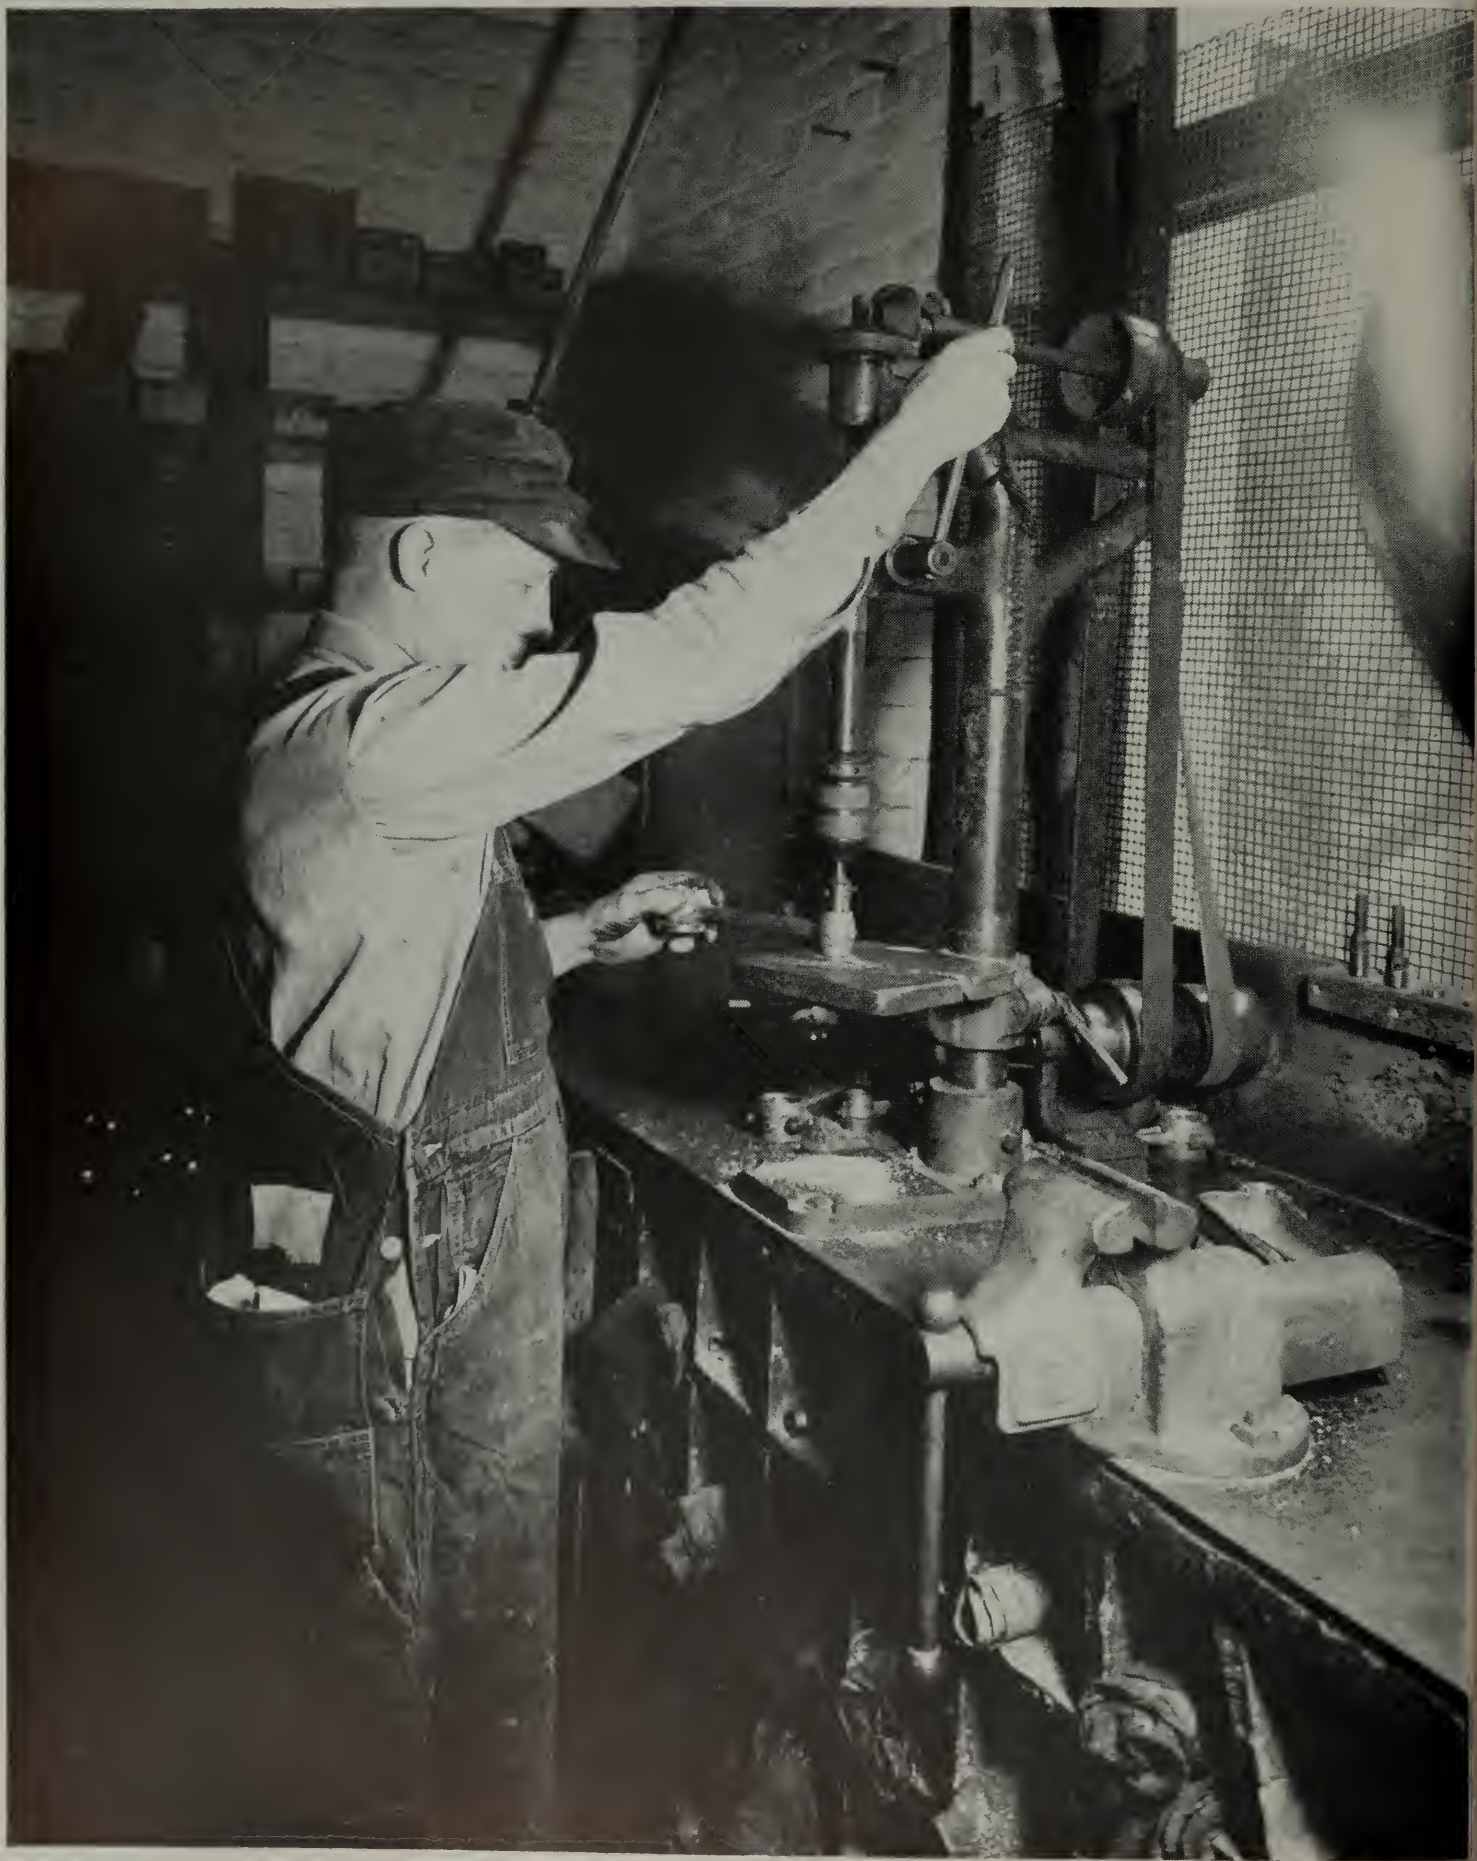
PLAINTIFF'S EXHIBIT No. 30

All babbitt bearings except the twenty per cent which are finished to special undersize on the lathe shown in Picture 22 are now finished to size by a hydraulically operated broaching machine as shown in the above picture. The broaching tool which is used for this operation is held in the workman's right hand. It is composed of a number of horizontal cutters each of which removes about .0005 as the tool is forced through the bearing by the hydraulic pressure.
